Testing and Recommended Practices to Improve Nurse Tank Safety: Phase II

Phase II of this study continues multi-year research related to the occurrence and potential methods of remediating anhydrous ammonia (NH_3) nurse tank failures. Nurse tanks are cylindrical steel tank shells with hemispherical or elliptical end caps referred to as heads, designed to hold NH_3 in liquid form under significant pressure (see Figure 1). Widely used as an agricultural nitrogen-rich fertilizer, NH_3 is a caustic substance that requires great care when handling.

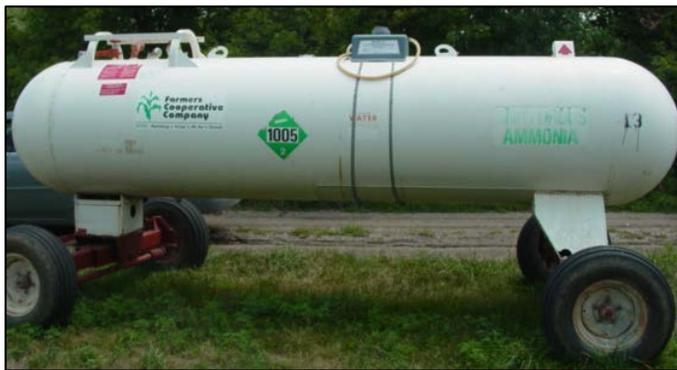
Figure 1. Photograph. Image of a typical nurse tank.

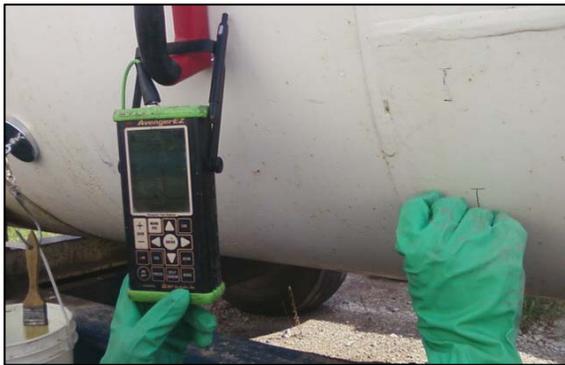
Figure 2. Photograph. Close-up of the ultrasonic unit used to conduct nurse tank inspections.

A side-angle ultrasound survey of 532 in-service nurse tanks was performed to measure ultrasound indications, most of which were indicative of cracks in the tanks' steel walls (see Figure 2). This survey showed that many tanks contain indications, but nearly all of these are too short and too shallow to pose a risk of tank failure. The 104 tanks that had received stress-relief annealing had dramatically reduced numbers and sizes of indications. The majority of ultrasound indications were found in the heat-affected zone (HAZ) near welds (i.e., the metal that got hot during welding but did not actually melt). Most indications lay perpendicular to head-to-shell welds. Likewise, most of the indications occurred at or above the 80-percent fill line. In this portion of the tank, ammonia vapor (with no water) contacts the tank's inner wall surface. Below the 80-percent fill line, liquid ammonia with water contacts the tank's inner wall surface.

Ultrasonic testing is an effective method for determining the location and size (though not the depth) of potential cracks. Ultrasonic testing should be performed on the HAZ and the fusion zones of all nurse tank welds as a routine, periodic inspection procedure. If inspection of all welds on tanks is deemed too costly, the majority of SCC problems could be identified by inspecting the circumferential welds above the 80-percent fill line.
